# DEVELOPMENT OF HIGH-SPEED BALANCING TECHNOLOGY

R. DeMuth and Dr. E. Zorzi

**MECHANICAL TECHNOLOGY INCORPORATED**

NASA Lewis Research Center  
Contract NAS 3-18520  
David P. Fleming, Project Manager

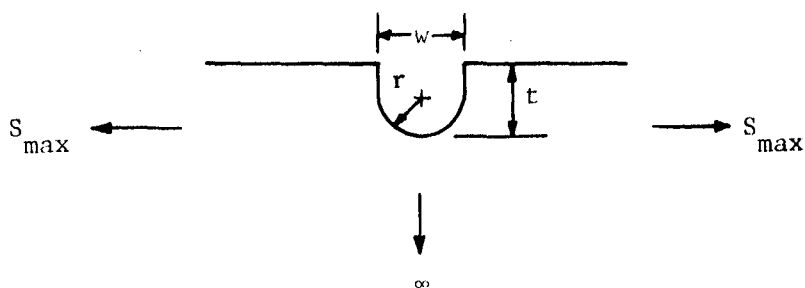
Estimates were made of the stress concentration,  $K_t$ , for each material's laser-burn groove so that a comparison could be made to the experimentally determined fatigue strength reduction,  $K_f$ , listed in table 5. These estimates were made assuming the laser burn to be a shallow elliptical notch in an infinitely wide body as shown below.

The expression [2] for calculating the stress concentration factor in bending for this configuration is

$$K_t = 1 + 2 \sqrt{t/r}$$

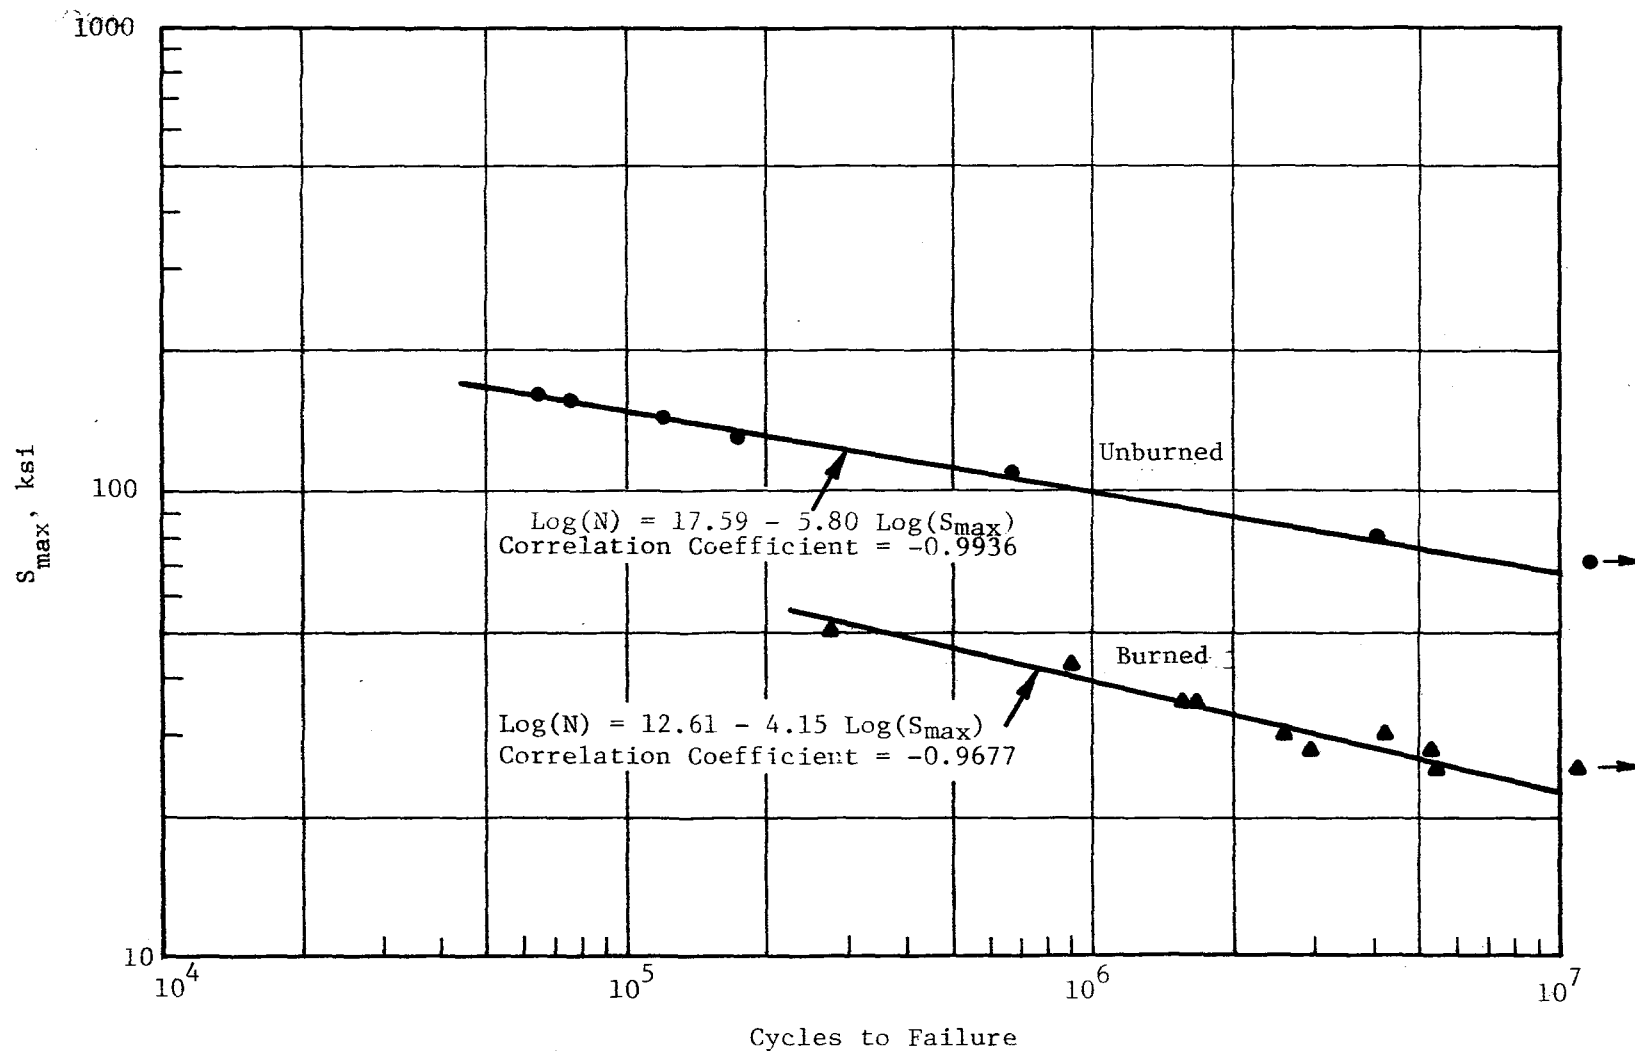
Figure 3 Inconel 718 Fatigue Data  
Stress Ratio (R) = 0.05

The fatigue data from both the baseline smooth specimens and the laser-burned specimens are presented in tables 1\* to 4 for each of the four materials investigated. These data are plotted as  $S_{\max}$  versus cycles to failure,  $N$ , in figures 3 through 6. Each figure contains all fatigue data for a particular material. The upper S-N curve (circular symbols) is the smooth radius specimen baseline data, and the lower S-N curve (triangular points) is the laser-burned specimen data.

For the purpose of comparing data, the fatigue strength was taken as the stress required to cause failure in  $10^7$  cycles, as determined by the fitted S-N curves. Table 5 contains the fatigue strengths at  $10^7$  cycles for each material. The last column in this table lists the fatigue strength reduction factors,  $K_f$ , defined as the ratio of smooth specimen fatigue strength to the laser-burned fatigue strength for a given material. In all cases, the effect of the laser burn was to reduce the fatigue strength by a factor ranging from 3 for Inconel 718 to a reduction of over 7 for the stainless steel 17-4 PH.

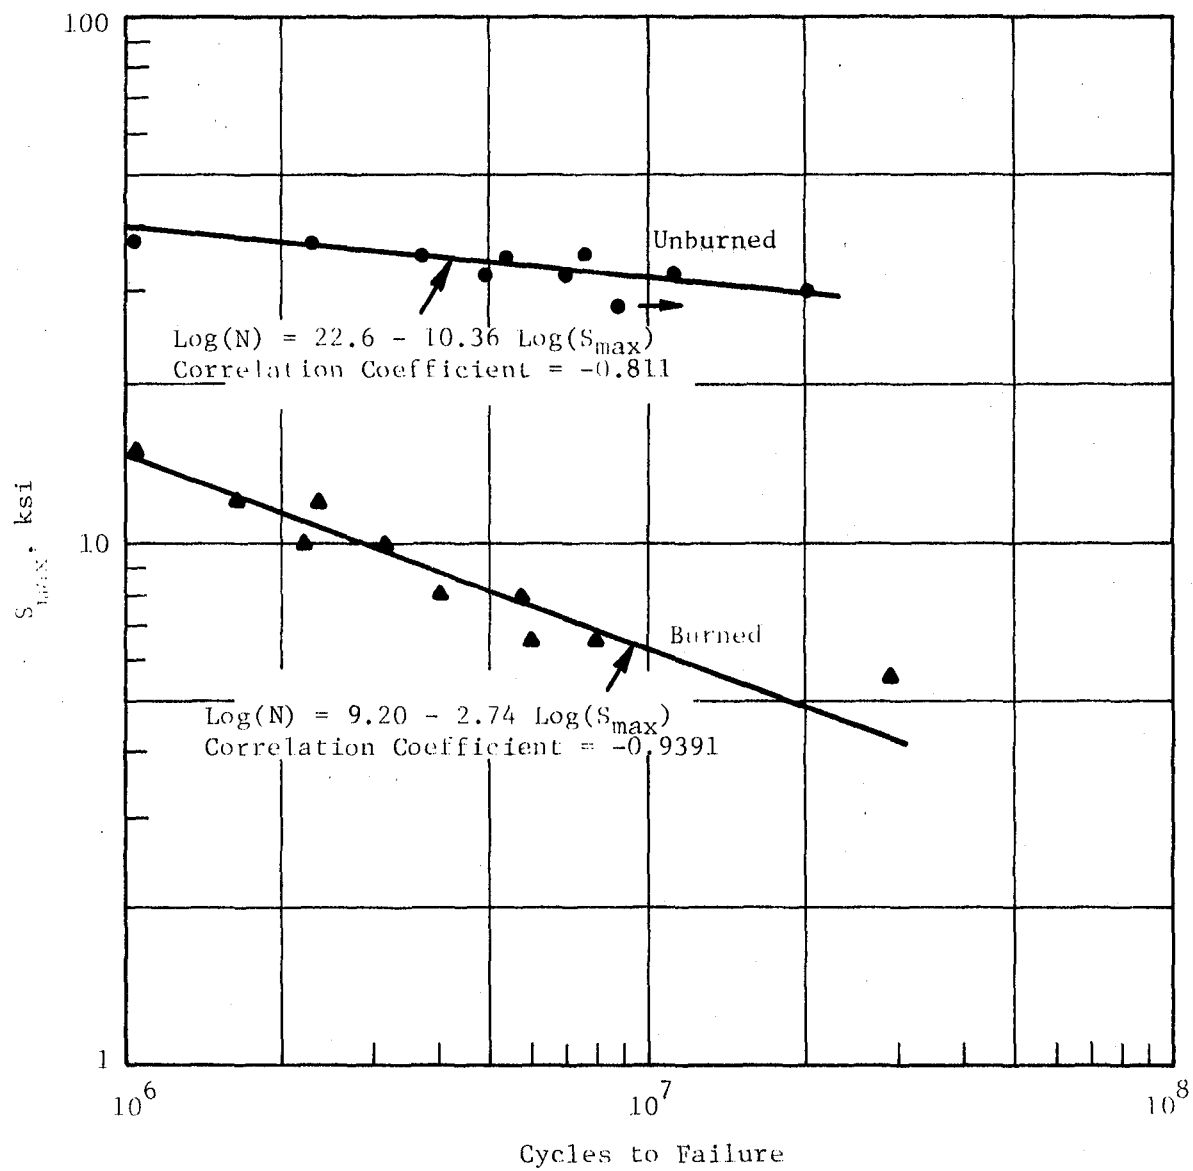
Figure 4 6061-T6 Fatigue Data  
Stress Ratio (R) = 0.05

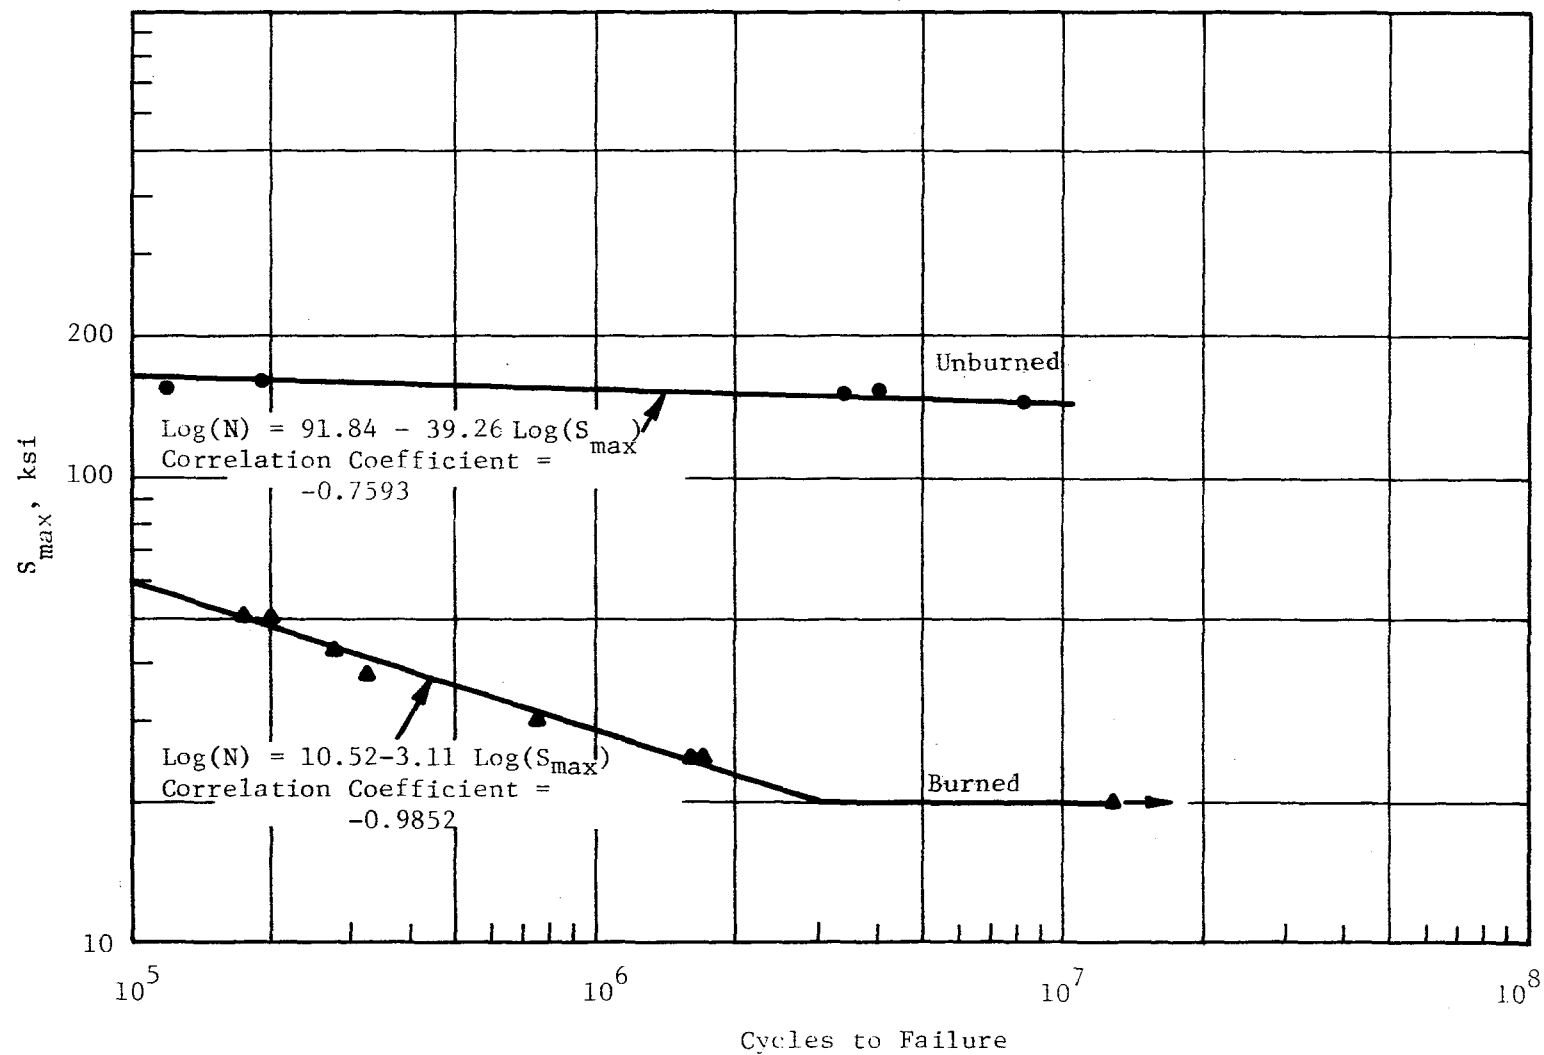
Figure 5 17-4 PH Fatigue Data  
Stress Ratio (R) = 0.05

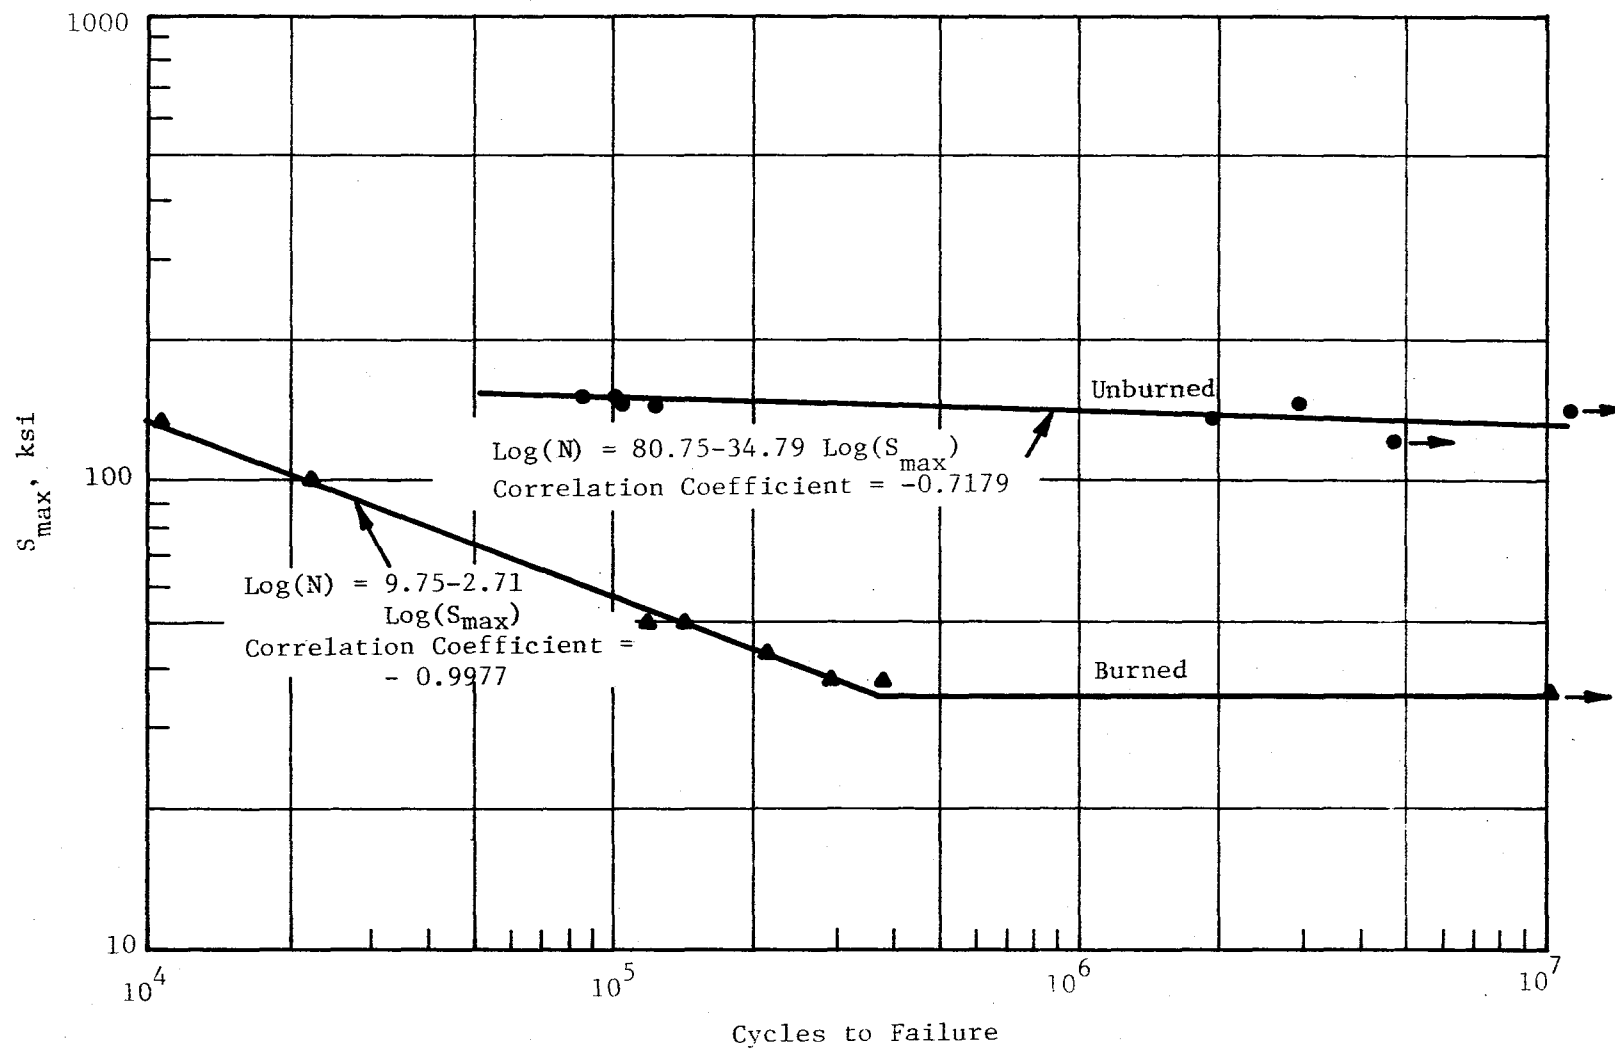
Figure 6 4340 Fatigue Data  
Stress Ratio (R) = 0.05

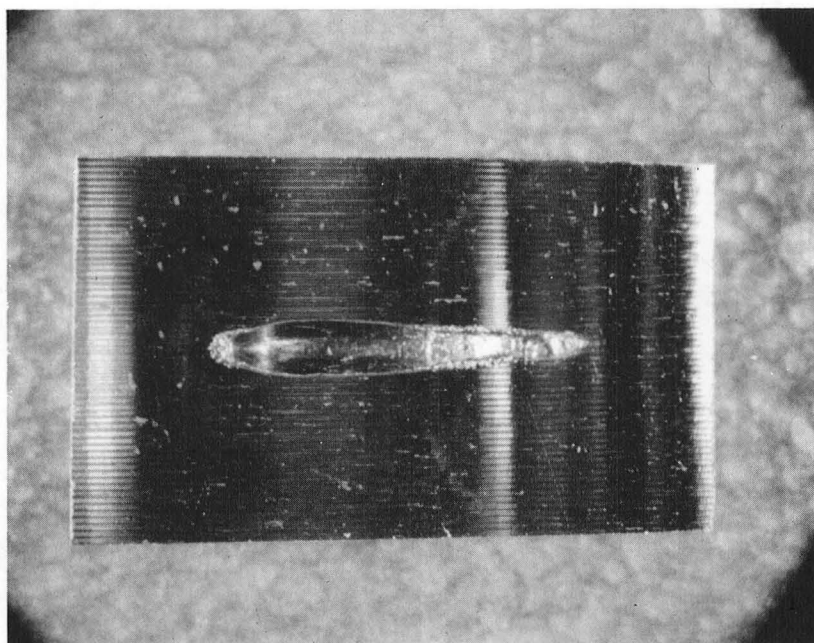
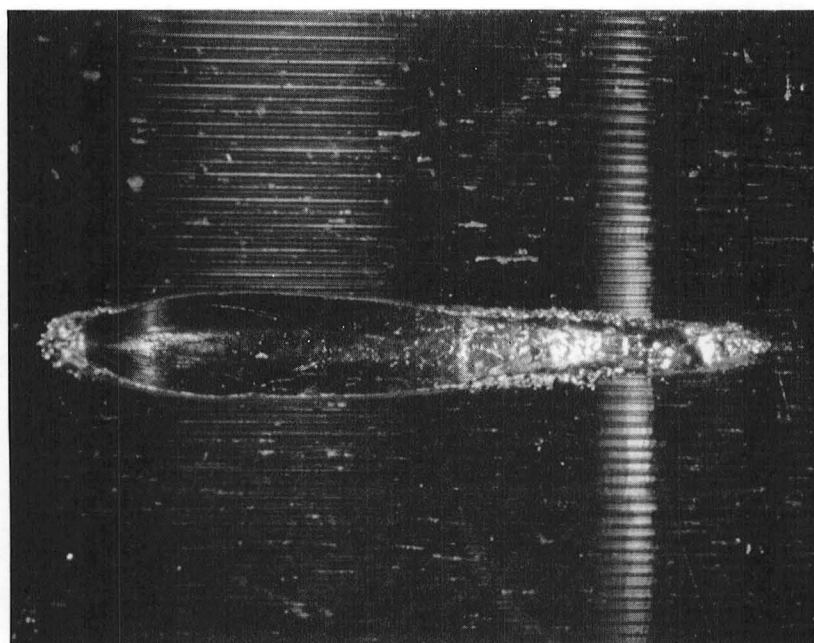
Figure 7 Laser Burn in 4340 Steel: Surface Profile

A. Macro photograph at 4.6X

B. Macro photograph at 9.6X

Figures 7A and B are the macrographs taken of a 4340, low alloy steel laser-burn specimen. The burn proceeds from left to right and is in the shape of a teardrop. The dimensions of this burn are

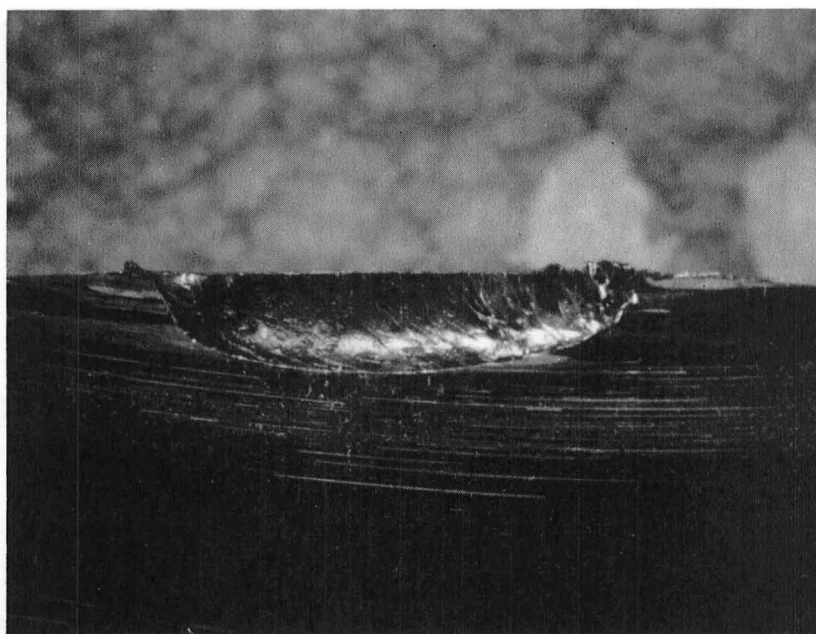
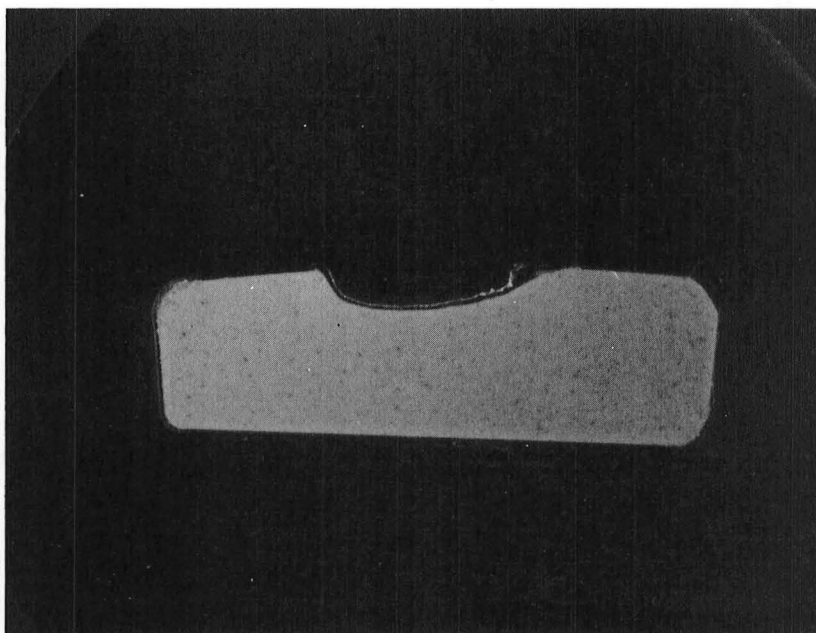
Figure 8 Laser Burn in 4340 Steel: Depth Profile  
Longitudinal Cross Section

A. Before Mounting at 9.6X

B. After Mounting and Metallographic  
Preparation at 4.2X

Figures 8A and B are the macrographs taken of the longitudinally sectioned laser-burn specimen. Figure 8A shows the cross section before mounting and metallographic preparation; figure 8B shows the cross section after mounting and metallographic preparation. The burn goes from left to right and the depth profile is approximately elliptical in cross section. The dimensions of this burn are

Figure 8A also shows that drops of molten metal have splashed back and frozen onto the wall of the burn trough. These drops are more apparent in the

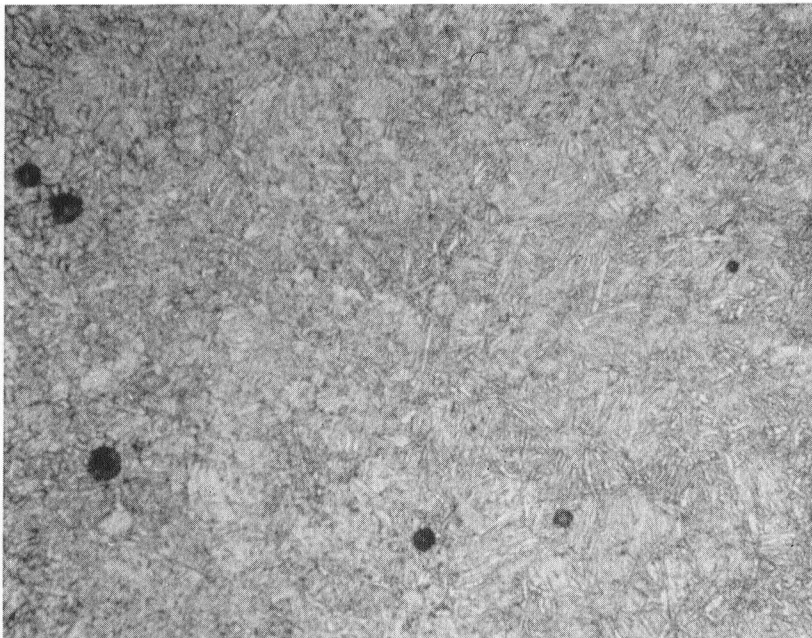
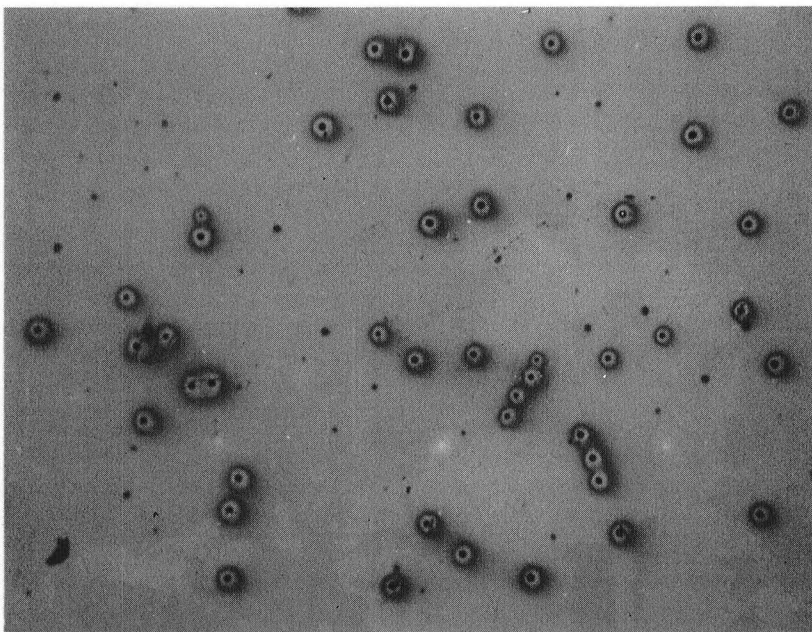
A. Martensitic Microstructure and Non-metallic Inclusion at 400X (L1274)

B. Nonmetallic Inclusions at 125X (L1265)

Figure 11 Bulk Microstructure of 4340 Steel (From longitudinal cross section specimen of laser burn as polished and water-rinsed to accentuate the inclusions)

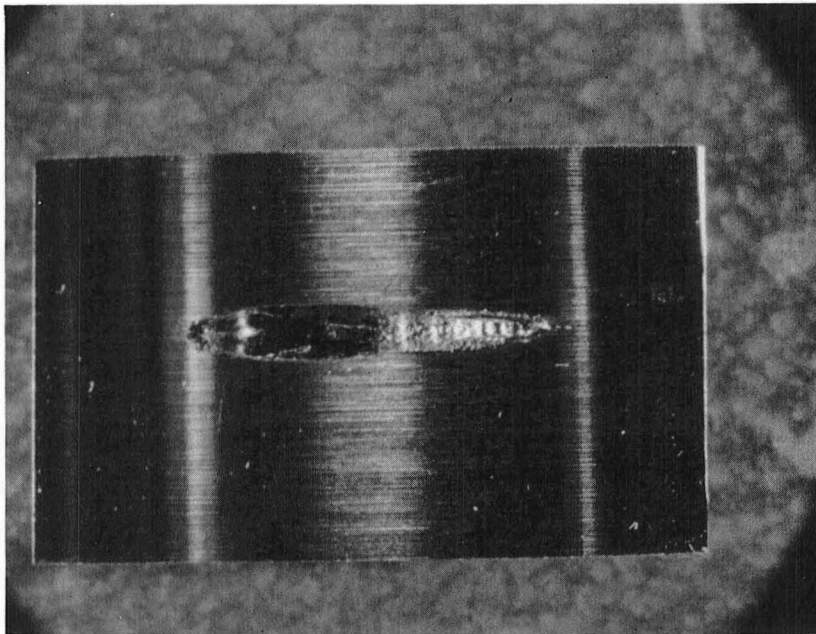
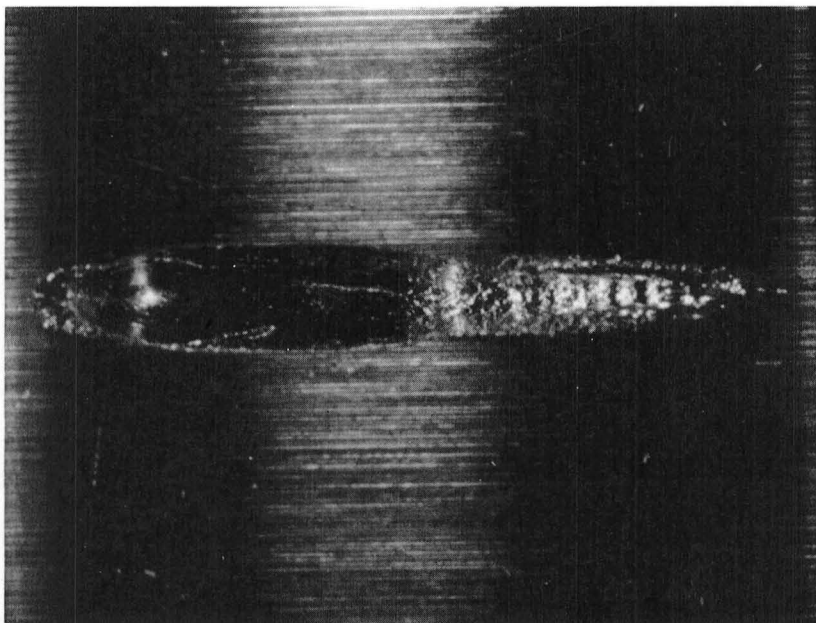
Figure 12 Laser Burn in 17-4 PH Stainless Steel:  
Surface Profile

B. Macrograph at 9.6X

Figures 12A and B are the macrographs taken of a 17-4 PH stainless steel laser-burn specimen. The burn goes from right to left and is elliptical. The dimensions of this burn are

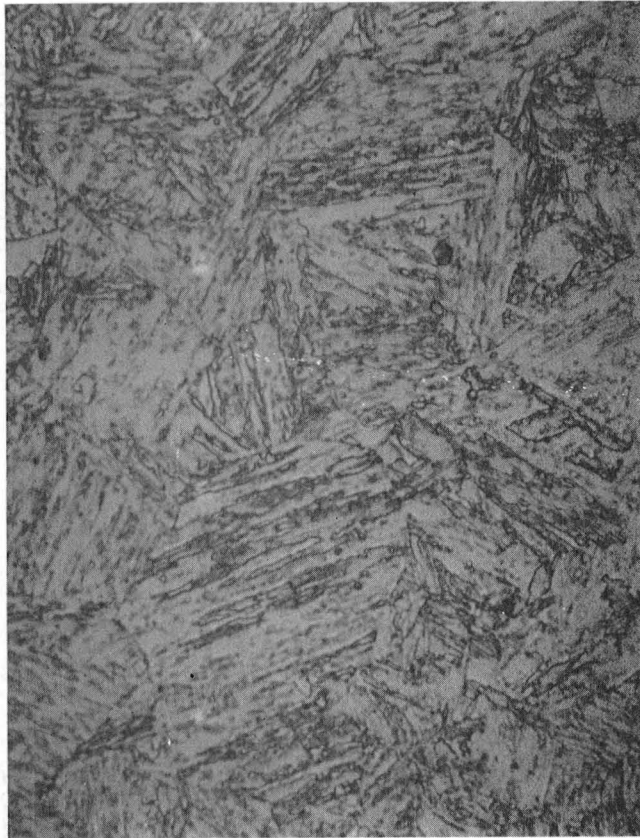
Figure 15 Bulk Microstructure of 17-4 PH Stainless Steel (From Longitudinal Cross-Section Specimen of Laser Burn) Martensitic Structure

Figure 15 is a micrograph of the bulk microstructure of the 17-4 PH stainless steel in the longitudinal cross-section specimen shown in figure 13. The structure is low-carbon martensite (with some delta-ferite), which contains the complex strengthening precipitate resulting from the aging treatment.

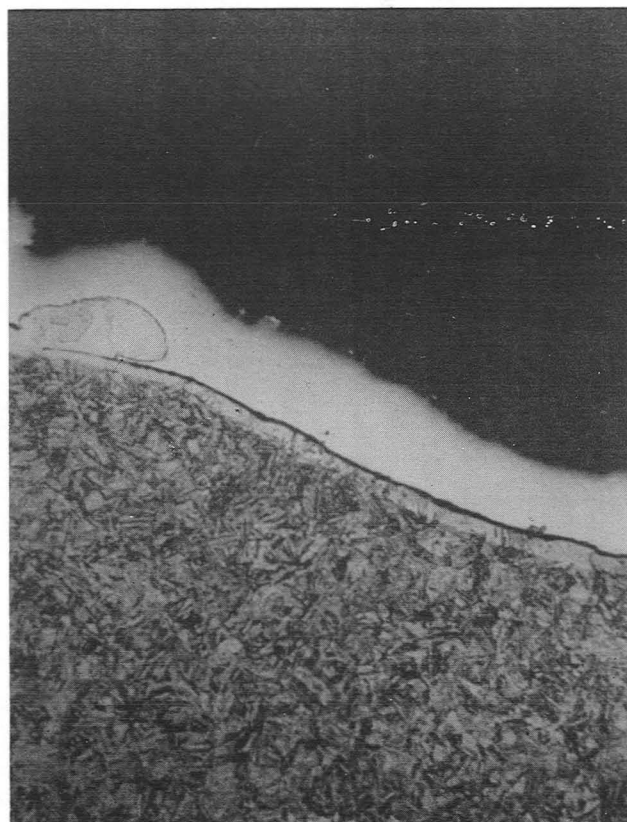
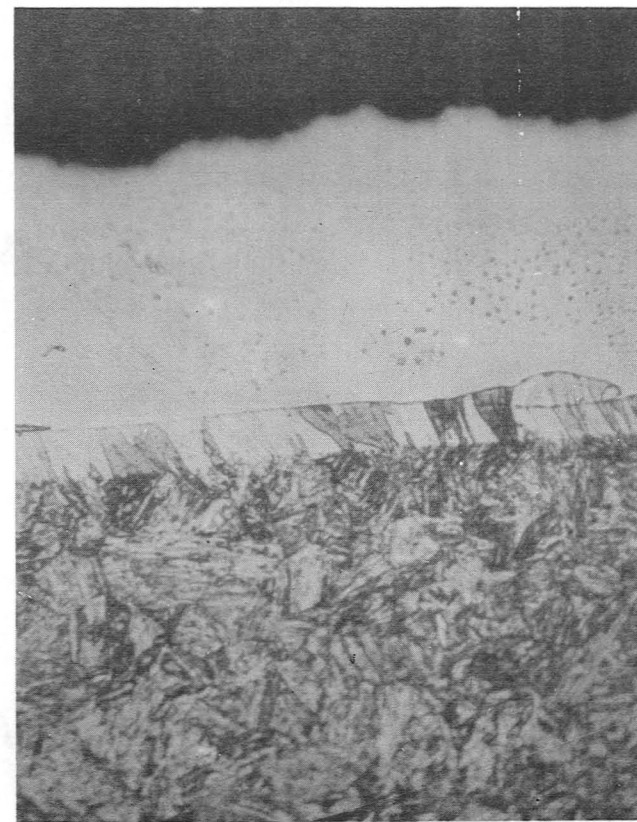
A. Midsection of Laser Burn (L1271)  
at 125X

B. Midsection of Laser Burn (L1269)  
at 400X

Figure 16 Microstructure of the Laser-Affected Zone in 17-4 PH Stainless Steel  
(Directionally Solidified Martensite)

Figures 16A and B are micrographs of the microstructure in the LAZ, approximately at the midpoint (beginning to end) of the laser burn. The average thickness of the LAZ is 0.00071 in. The structure is directionally solidified martensite. The martensite grains have grown epitaxially from the bulk grains,

Cross sections of some drops, such as those evident in the SEM view in figure 14, are seen at the middle left of figure 16A and middle right of 16B. At the very end of the trough and laser burn, there was insufficient heat to melt the metal but enough to transform the preexisting martensite to ferrite (larger, rounder grains). Figures 17A and B show the extent of the ferrite transformation.

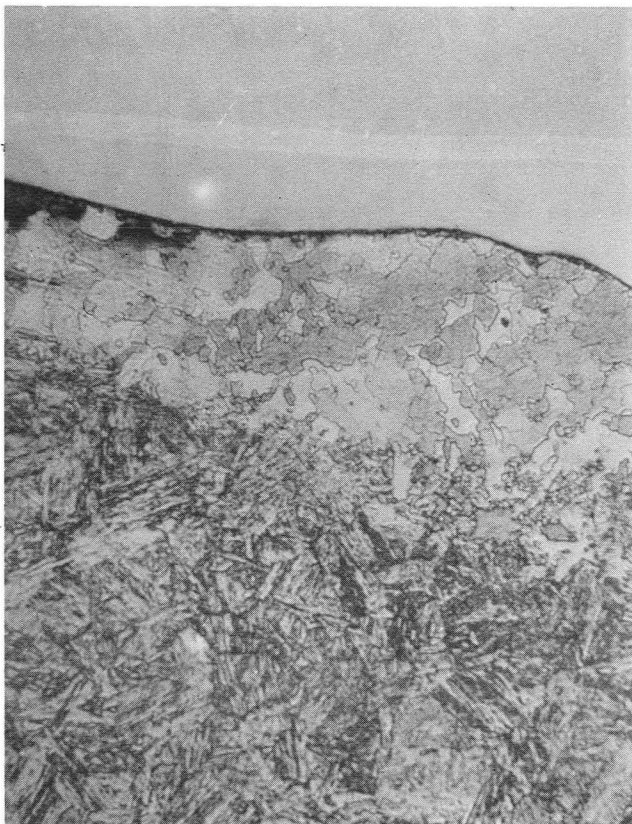
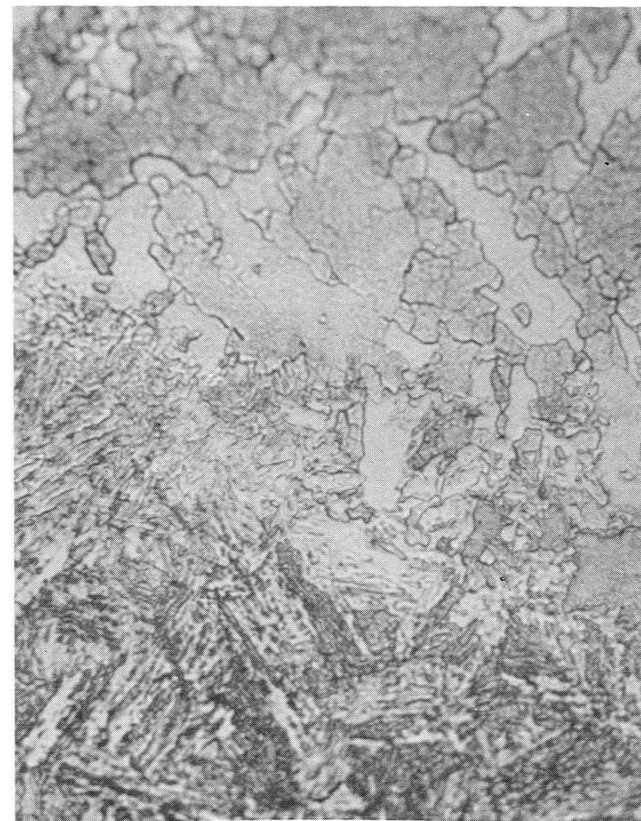
A. Very End of the Laser Burn (L1267)  
at 400X

B. Very End of the Laser Burn (L1268)  
at 1000X

Figure 17 Microstructure of the Laser Affected Zone in 17-4 PH  
Stainless Steel (Martensite-Ferrite Transformation)

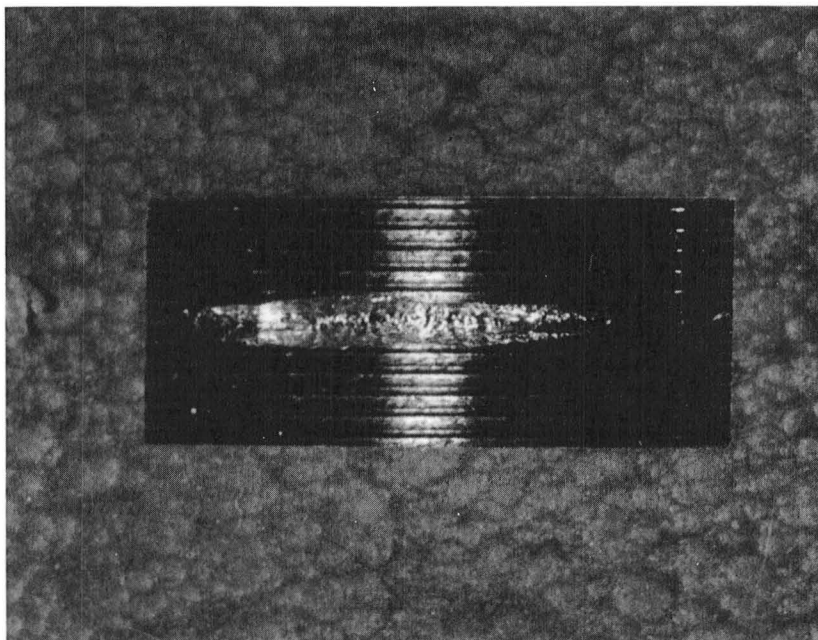
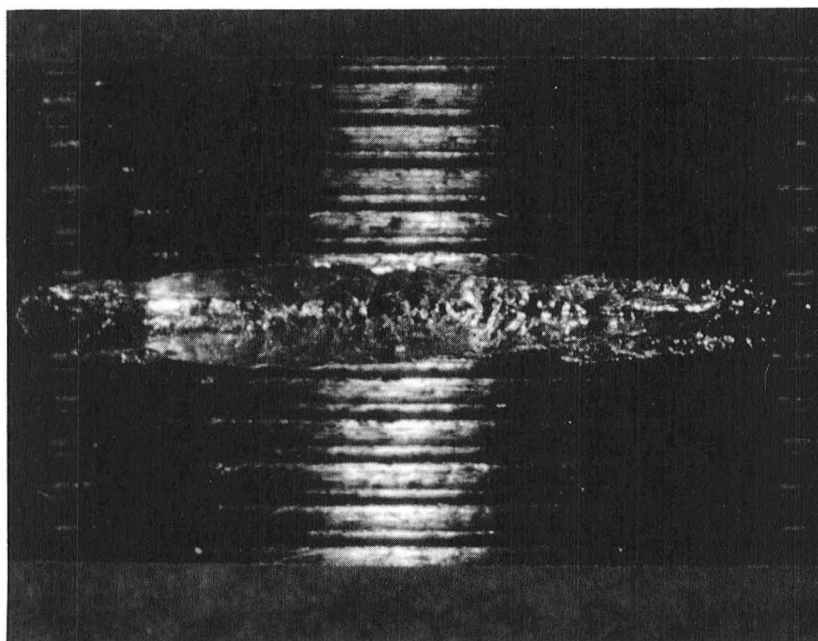
Figure 18 Laser Burn Inconel 718

A. Macrograph at 4.5X

B. Macrograph at 9.2X

Figures 18A and B are the macrographs taken of an Inconel 718 laser-burn specimen. The burn goes from right to left and has an elliptical outline. The dimensions of this burn are:

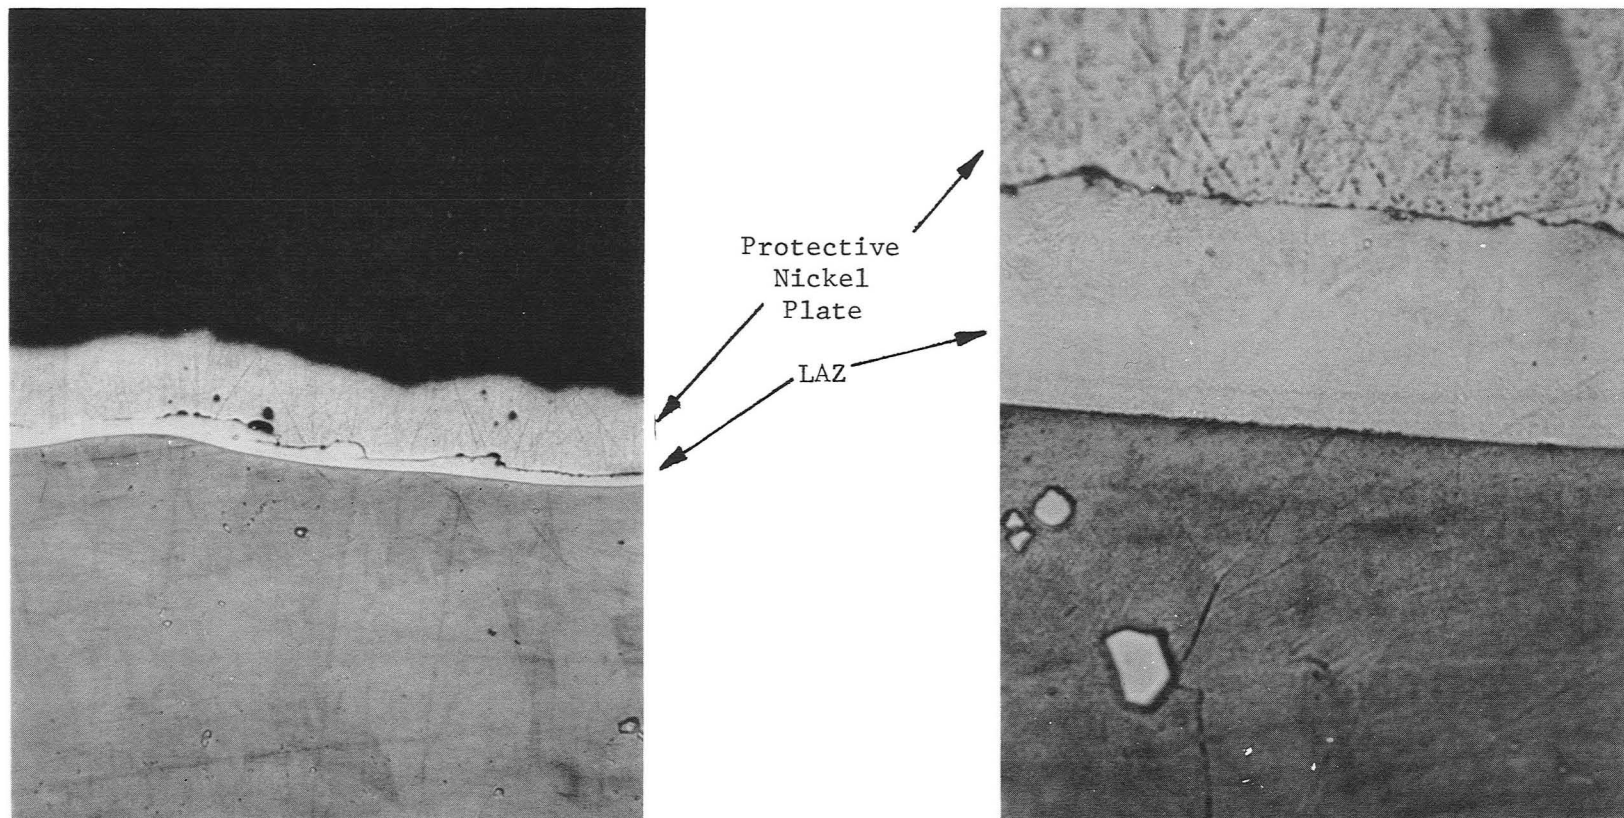
A. Midpoint of Laser Burn at 125X (L1431)

B. Midpoint of Laser Burn at 1000X (L1429)

Figure 21 Microstructure of the Laser-Affected Zone in Inconel 718 (LAZ: "As Cast" Gamma;  
Bulk: Wrought Gamma Matrix and Gamma Prime Precipitates)

Figures 21A and B are micrographs of the microstructure in the LAZ, approximately at the midpoint (beginning to end) of the laser burn. The average depth of the LAZ is approximately 0.00071 in. The structure of the bulk Inconel 718 beneath the LAZ is a wrought gamma matrix with gamma prime precipitates. The structure of the LAZ is "as cast" gamma solid solution with no gamma prime. Cross sections of some drops, as evident in the SEM view in figure 20, are seen in the middle of Figure 21A.

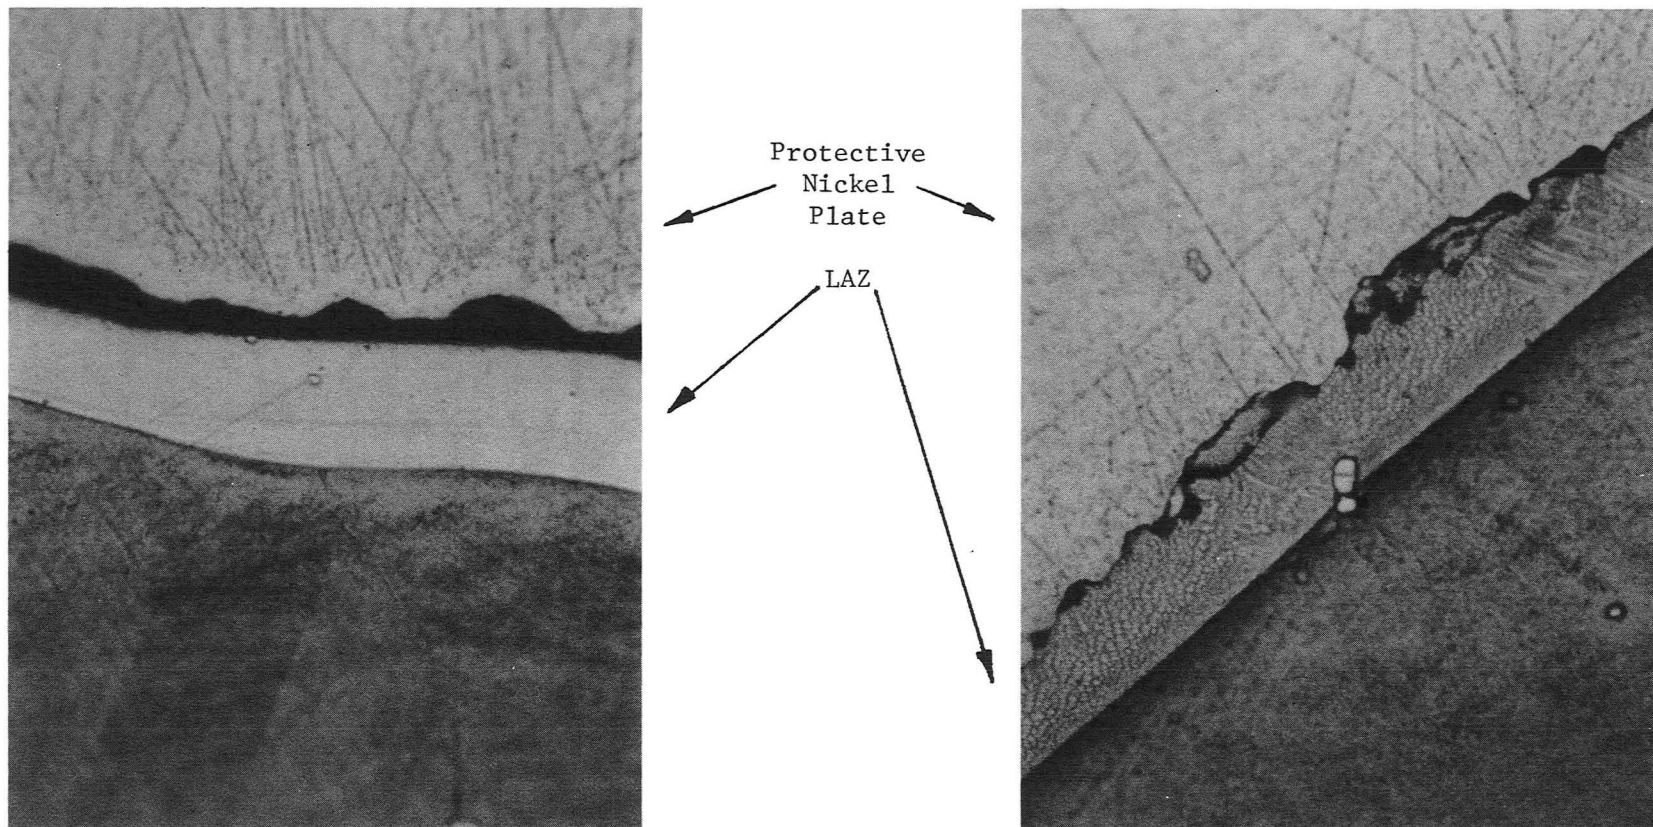
A. Near End of Laser Burn at 1000X (L1430)

B. Near End of Laser Burn at 1000X (L1428)

Figure 22 Microstructure of the Laser-Affected Zone in Inconel 718 (LAZ: "As Cast" Gamma, (Columnar Growth Evident) Incomplete Melting of Ti(C,N) Particles)

Figures 22A and B show the LAZ from near the end of the burn. In this region, columnar growth in the solidified LAZ is more evident. This is especially evident in figure 22A. Furthermore, insufficient heat was developed to completely dissolve the titanium carbonitride particle evident in the center of figure 22A and other smaller ones evident in the LAZ of figures 22B and 21B. However, all gamma prime appears to have dissolved (indicated by white color instead of darkening gray as in the bulk).

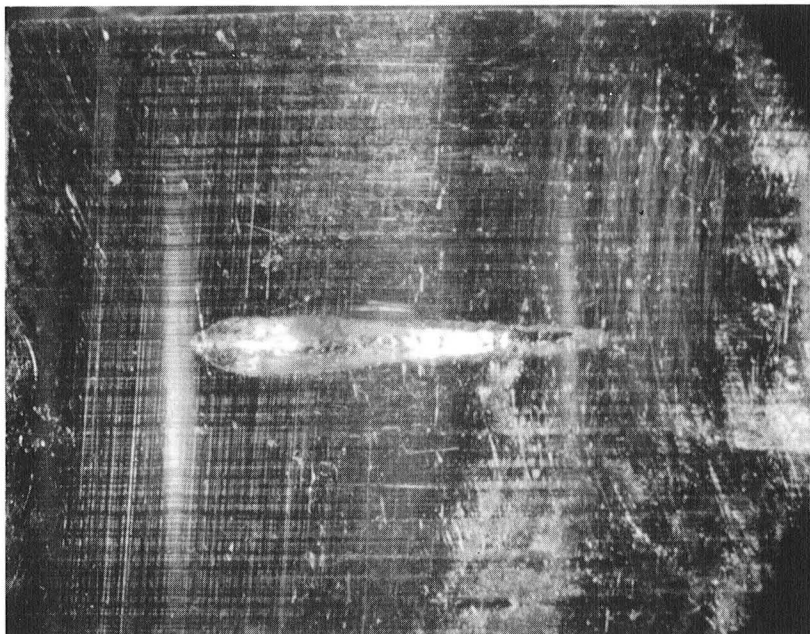
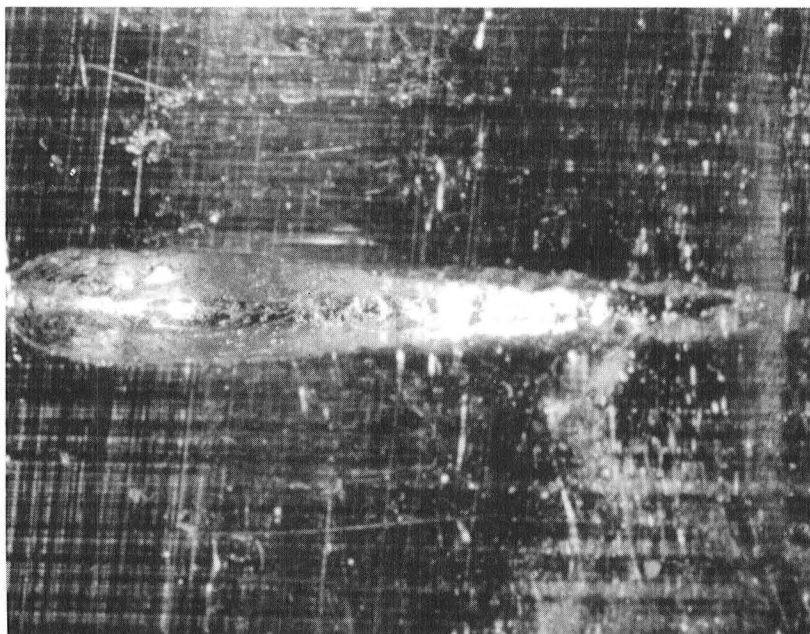
Figure 23 Laser Burn in 6061-T6 Aluminum: Surface Profile

A. Macro photograph at 4.64 X (L1257)

B. Macro photograph at 9.6X (L1258)

Figures 23A and B are the macrographs taken of one of the 6061-T6, aluminum alloy, laser burn specimens. The burn proceeds from left to right and is in the shape of a teardrop. The dimensions of this burn are

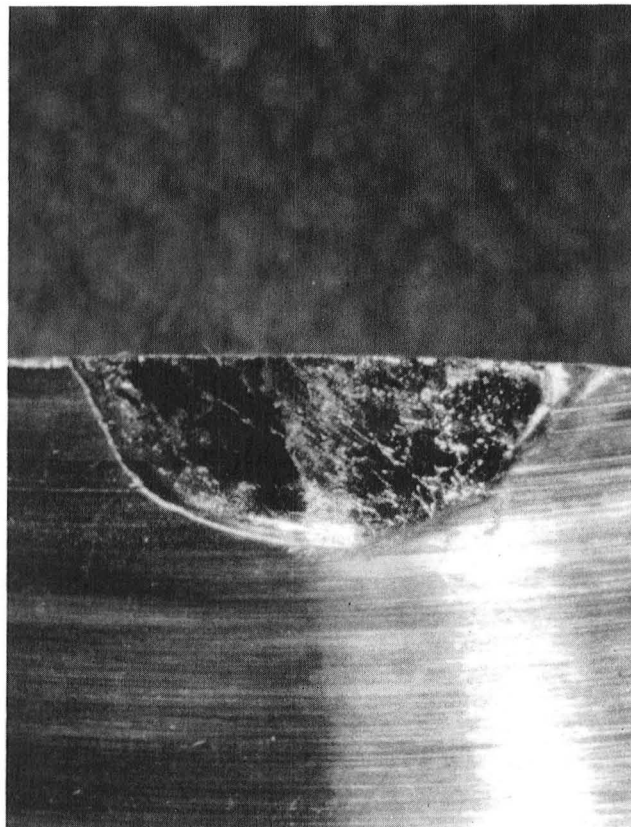
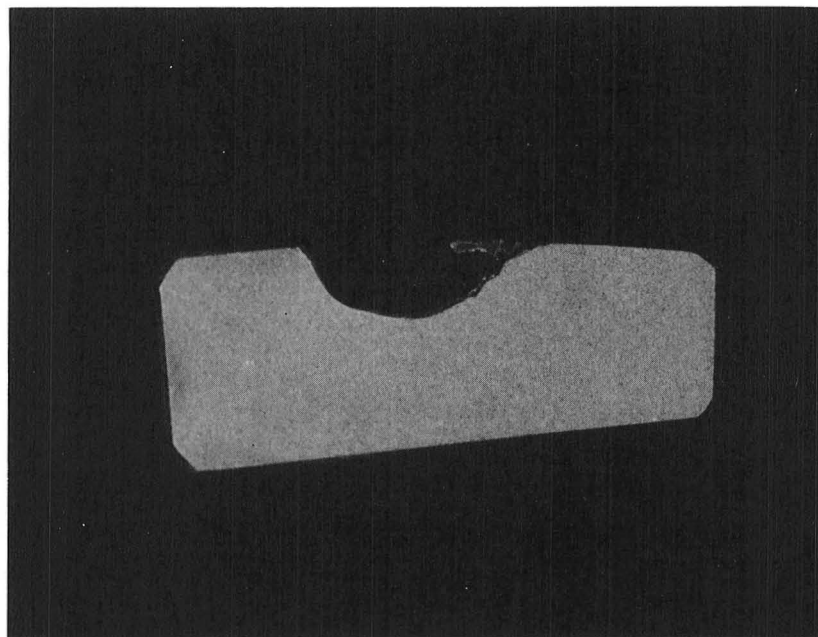
Figure 24 Laser Burn in 6061-T6 Aluminum: Depth Profile  
Longitudinal Cross Section

B. After Mounting and Metallographic Preparation at 4.25X (L2202)

Figures 24A and B are the macrographs taken of the longitudinally sectioned laser-burn specimen. Figure 24A shows the cross section before mounting and metallographic preparation; figure 24B shows the cross section after mounting and metallographic preparation. The burn goes from left to right and the depth profile is approximately semicircular in cross section. The dimensions of the burn are

Figure 24A also shows the drops of molten metal that have splashed back and frozen onto the wall of the burn trough. These drops are more apparent in the scanning electron microscope view in figure 25, looking down into the trough of the laser burn shown in figure 23. The laser burn goes from bottom to top in the photographs. The widest part of the laser burn (approximately 1/4 the distance from the beginning to the end of the burn) is approximately at the center of the figure. The solidified surface of the trough appears pimpled and puckered and has microcracks. The puckering and microcracking is shown more clearly in the SEM micrographs of figures 26A, B and C. The puckering and cracking may be due to the brittle oxide film forming on the molten metal before resolidification. This condition might be avoided if the burn were conducted in a vacuum or in an inert gas atmosphere such as helium or argon.

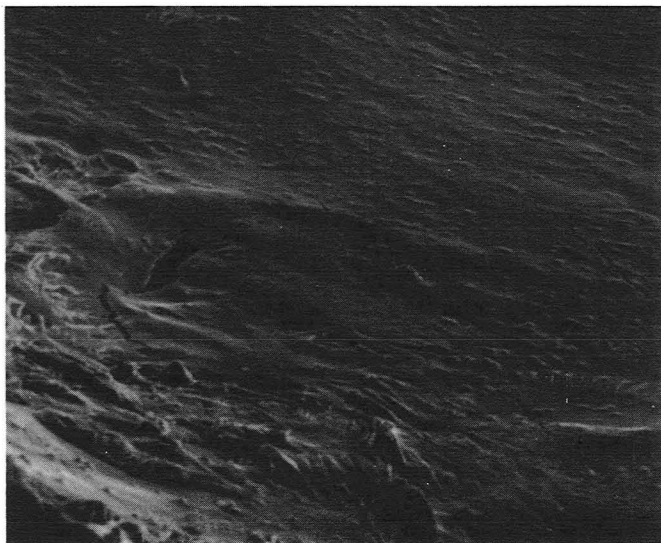
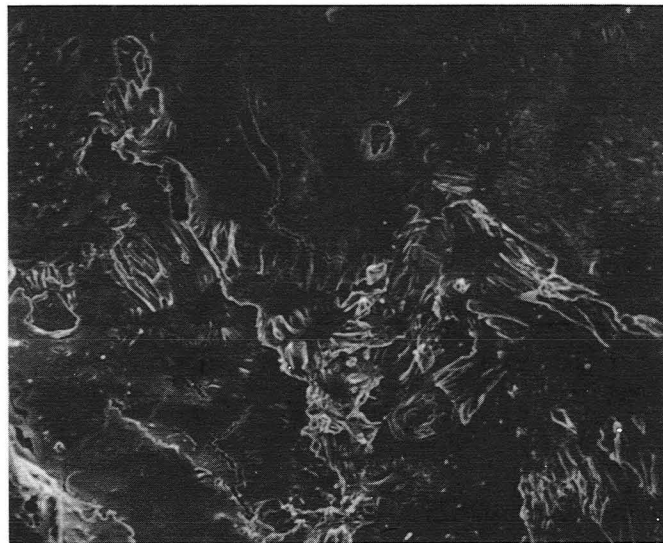
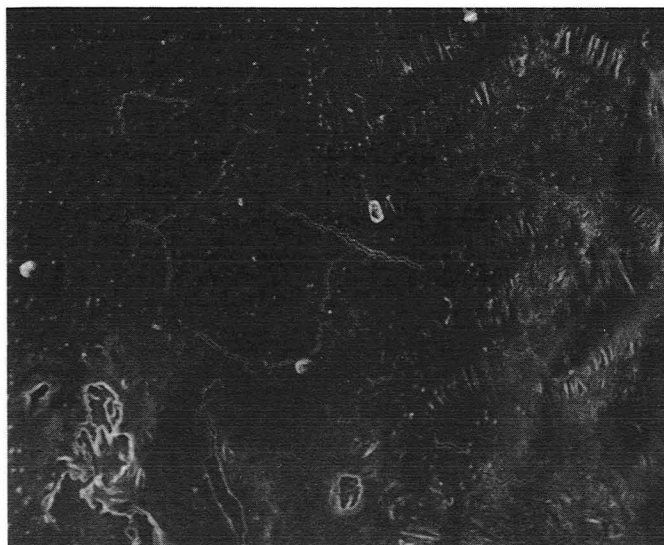
Figure 26 Puckering and Microcracking in 6061-T6 Aluminum Laser-Burn Surface
